LONDON TRANSPORT
OFFICE OF THE ENGINEERING SUPERINTENDENT (ROAD SERVICES)

G.S.I. 209 - ROUTEMASTER INSTRUCTION 96, SECTION 2.

RM GEARBOX - CURING THRUST PAD FOUL

This Instruction applies to all RM type gearboxes, unit codes GB.32 and GB.39.

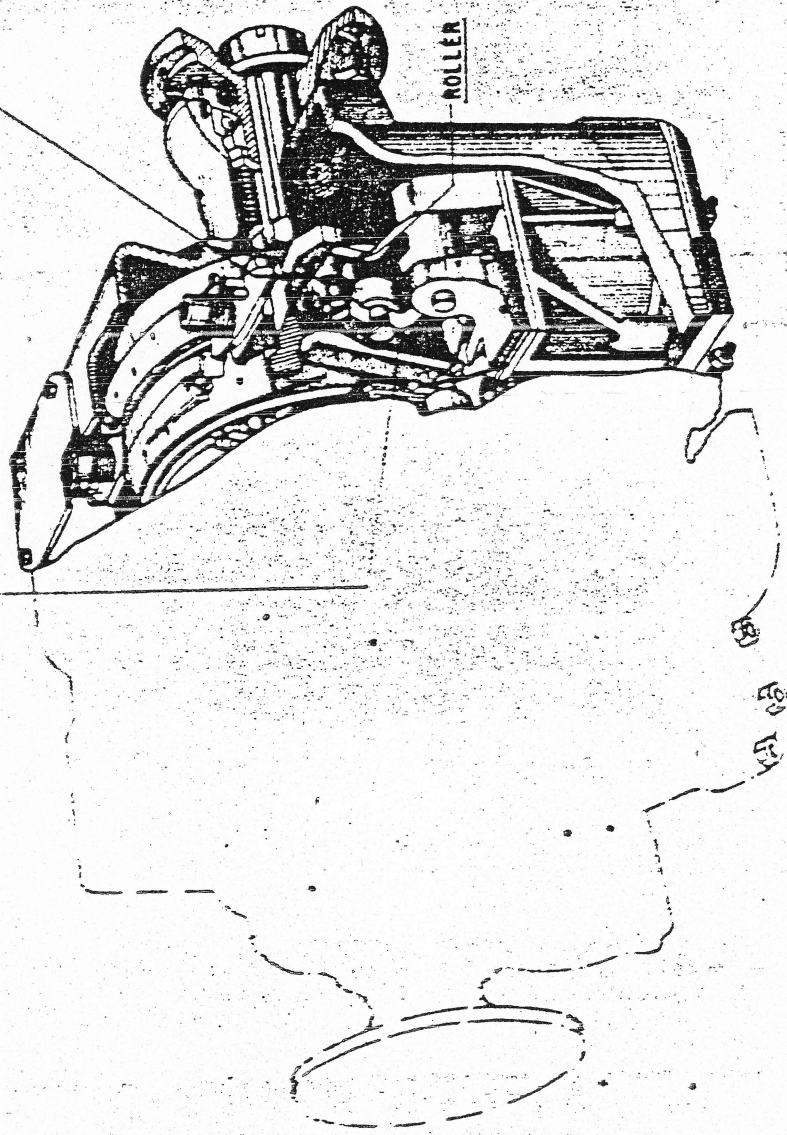
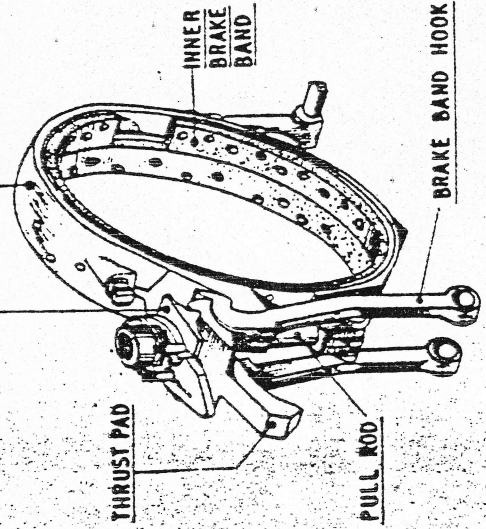
FOULING OF THRUST PAD 2ND AND 3RD SPEED

If second or third speed on any RM gearboxes found to be slipping on engagement and on removing the gearbox lid, it is found that the speed is engaging slowly and jerkily, then a fouling thrust pad must be suspected.

N.B. Excessive end float of the gearbox bands in the base plate is felt to be largely responsible for the fouling of the thrust pad; when gearboxes are overhauled at Chiswick shimming of the band anchorages is carried out to prevent this excessive end float.

AREA OF FOUL
BETWEEN TAILPIECE OF
THRUST PAD & PIVOT LINK

Examine the thrust pad flanks and if there is any sign of rubbing against the shoulders of the pivoted link then relieve the flanks of the thrust pad by grinding 45° chamfers to reduce or prevent the foul.
